# Case Study: Thermal Contraction of a PVC Membrane and EPS Insulated Roof Assembly in Alaska's North Slope Borough

By Grace Wong, AIA, PE, LEED AP BD+C, and Christian Gorry, RRC, RRO

We investigated the failure of a low-slope PVC roof assembly in Deadhorse, Alaska, in 2018. Deadhorse is a small town in Alaska's

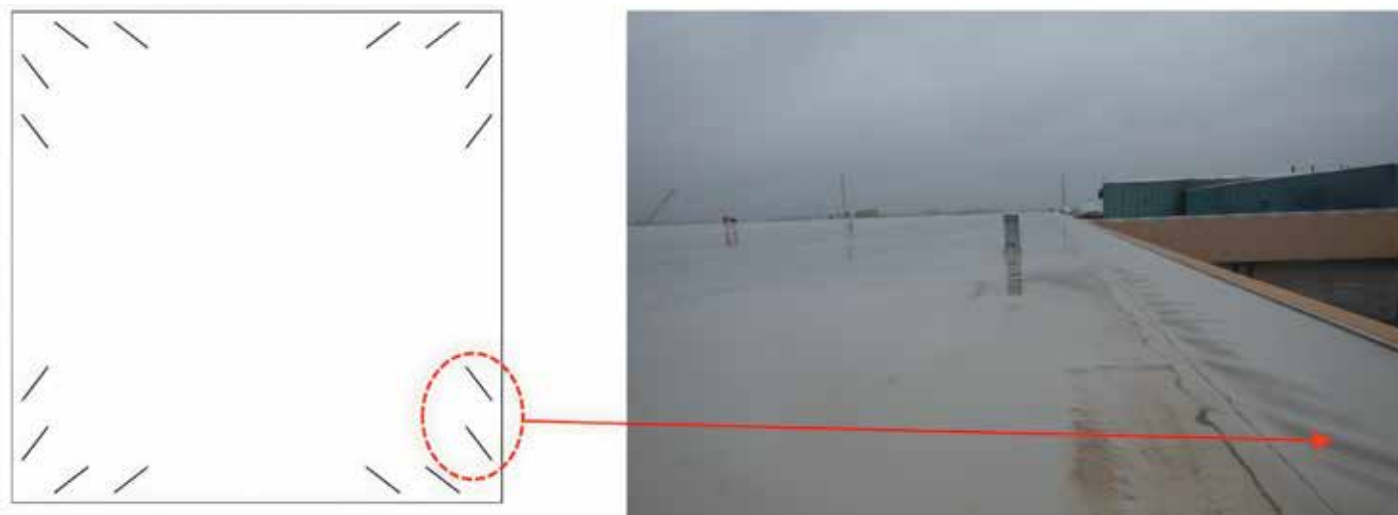
We performed a visual survey of the roof assembly from the interior and exterior and noted that the roof membrane at each corner of the building was wrinkled in a diagonal pattern that pointed toward the corners (Fig. 5). Membrane adhesion to the coverboard generally appeared intact but we noted “excess” or wrinkled membrane at several locations at the coverboard joints where the membrane was not adhered (Fig. 6).

**Figure 5.** Roof plan and a related photo of the shear pattern observed at the roof corners.

membrane itself. We suspect this was the case because the pattern of wrinkles on the roof was strongly correlated with patterns of uniformly and concentrically applied tensile stress on the roof membrane on a square-shaped roof (Fig. 5). The membrane appeared to be pulling away from the roof edge at all elevations and toward the center of the roof. The built-up wood roof curb was attached with 0.130 in. (3.3 mm) × 3½-in. (89 mm) nails at approximately 8 in.

Refer to Fig. 5 and note that the membrane at the perimeter is in "shear" with respect to the main field of the roof; also, the pattern of distress is consistent with membrane that is being "drawn" toward its center. Also note, ridges in the membrane at insulation panel joints indicate lack of adhesion, but there was also a significant amount of "extra" membrane at these joints, and it would not have been possible to install the membrane in this manner. These ridges occurred after the original installation, and they were most likely the result of contraction of combined PVC and EPS in the winter followed by expansion of the PVC membrane in warmer weather.

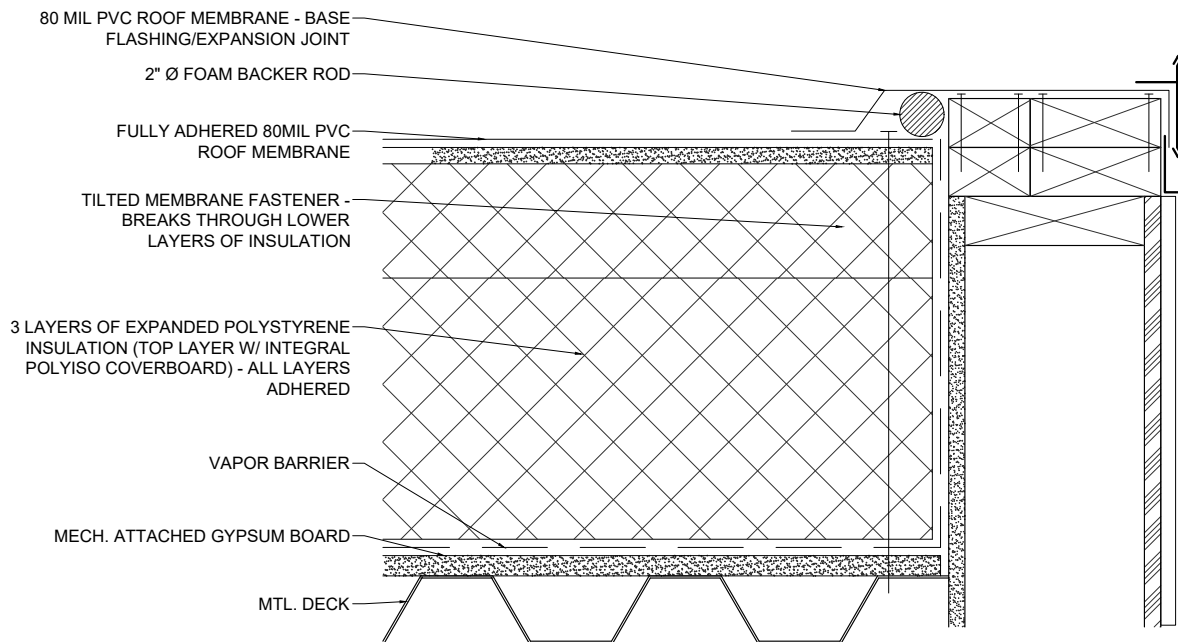
From a lift and from the roof, we observed that the top edge of the roof curb had rotated up and back toward the building and failed along the entire roof perimeter (Figs. 7 and 8). The wood-framed curb was constructed from four pieces of 2 x 6 (30 x 140 mm) and 3 x 6 (25 x 131 mm) dimensional lumber attached with 0.130-in. (3.3 mm) nails in two rows spaced alternately at approximately 8 in. (203 mm) on center (Figs. 9 and 10). The top plate of the wall appeared to be intact and had not been displaced. The failure of the roof edge at all four elevations was clearly visible and appeared to be the most severe at the center of each elevation (Fig. 11-13).

**Figure 7.** Roof assembly at a failed roof edge—as designed.

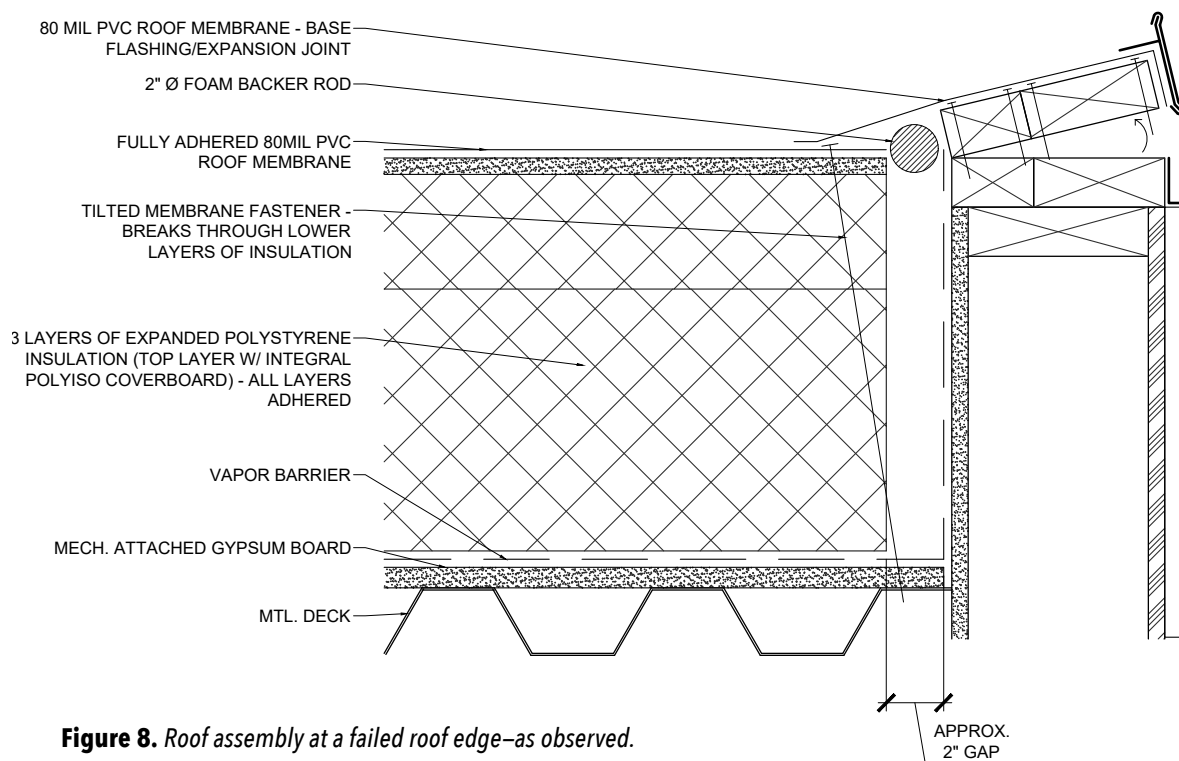
**Figure 8.** Roof assembly at a failed roof edge—as observed.

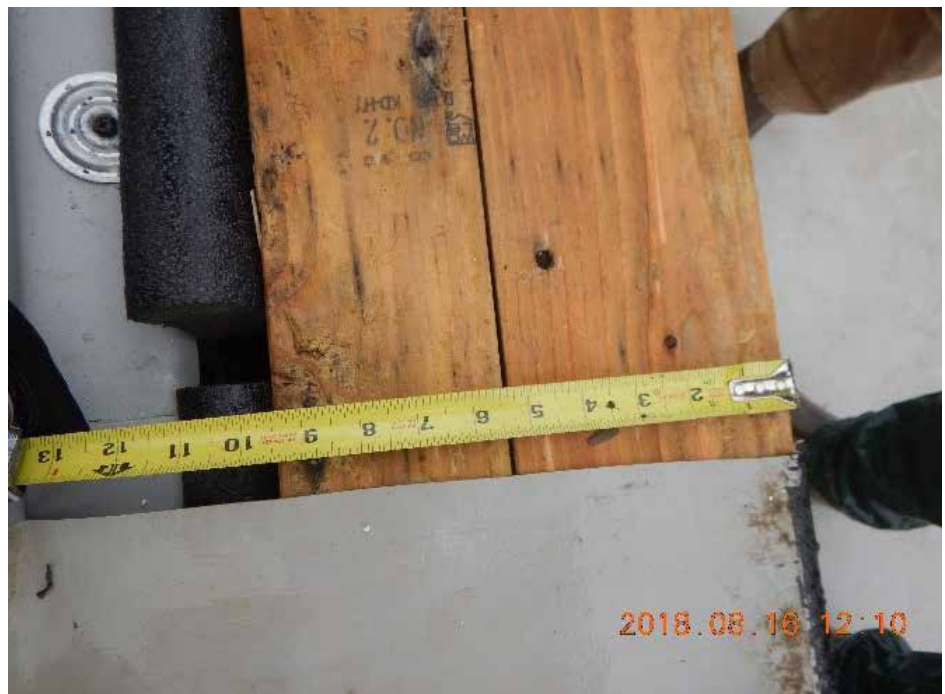
Figure 9. Top of roof curb.

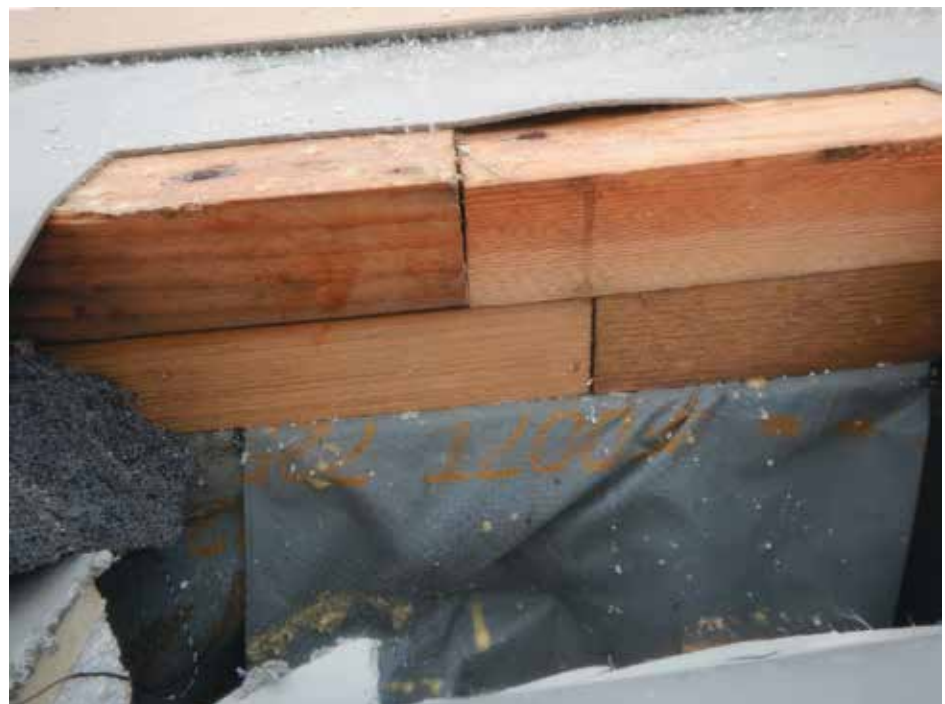
Figure 10. Built-up roof curb.

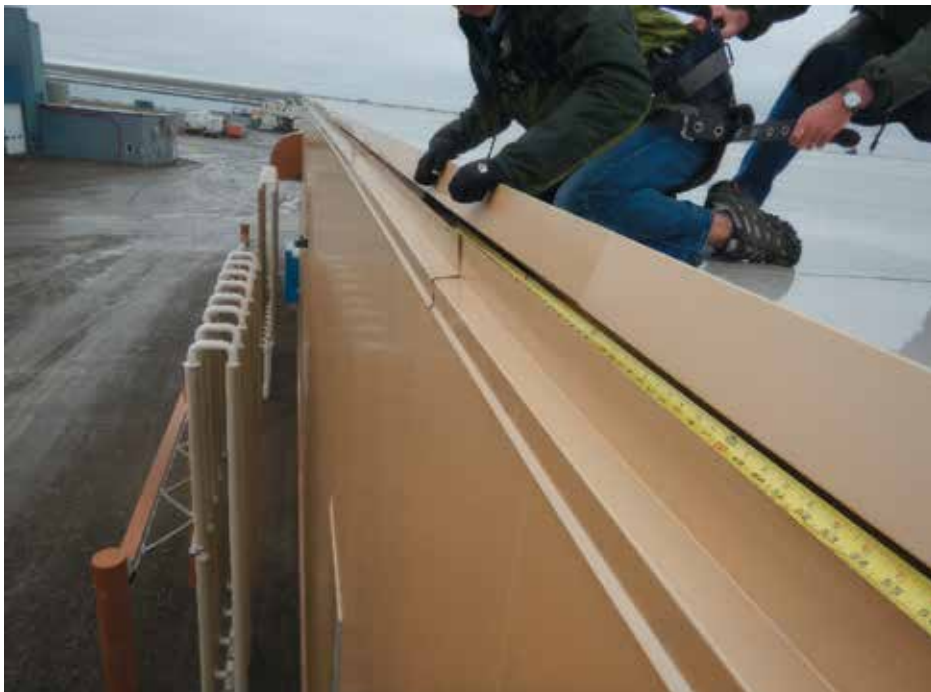
**Figure 11.** Failed roof edge at north elevation.

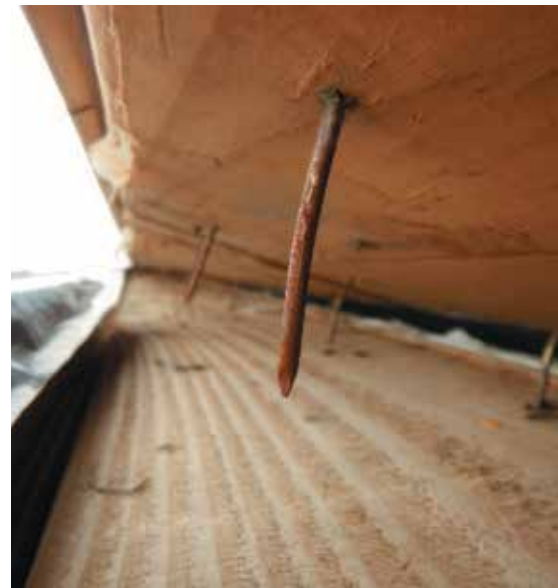
**Figure 13.** Failed roof edge at south elevation.

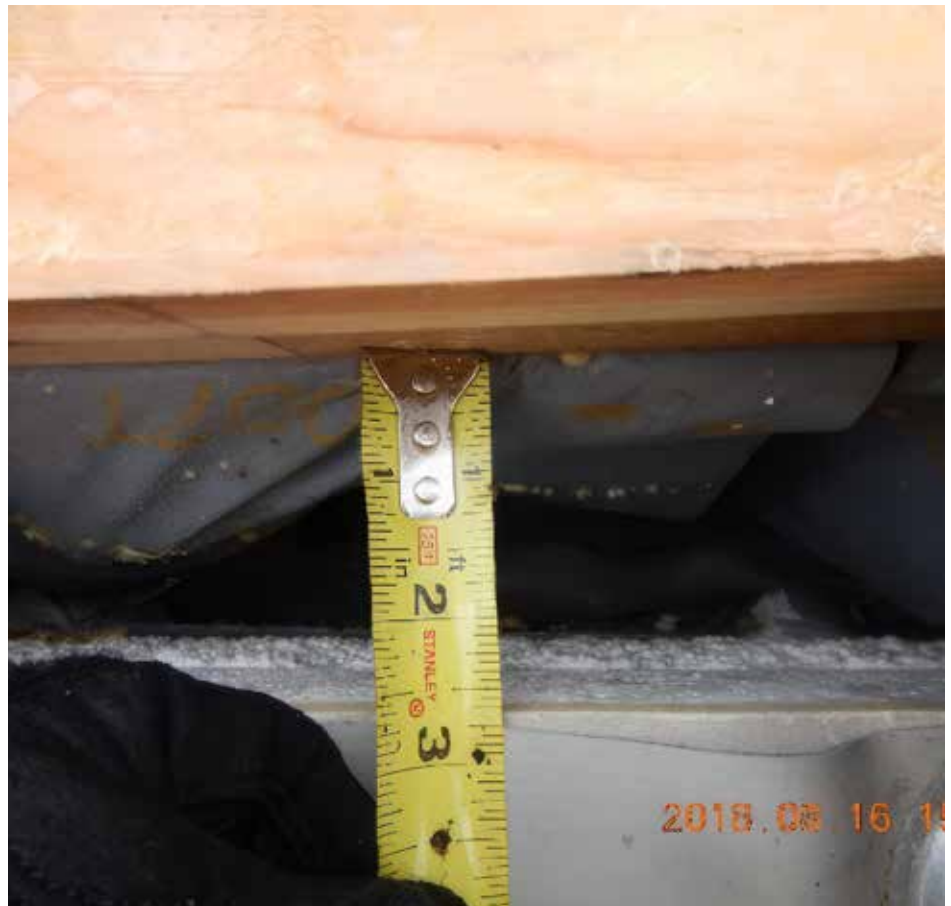
At each opening, we noted the components and attachment methods described in the roofing submittal issued during construction appeared to be present. Also, the adhesion between the roof membrane and cover board and between layers of rigid insulation appeared to be intact. At both openings, there was an approximate 2 in. (51 mm) gap between the edge of the insulation and the inside face of curb (Figs. 15 and 16).

**Figure 15.** An approximate 2-in. gap was observed at both openings.

Due to the limitations of the short arctic roofing season and logistics of getting multiple experts to this remote location, we were limited to one day of exploratory investigation and two openings. We observed an approximate 2-in. (50-mm) gap at both openings, but we suspect that this gap existed around the entire perimeter of the roof. The original contractor indicated that the insulation was installed tight to the curb, i.e. the insulation gap was not present initially and therefore developed over time, which is consistent with our field observations. Out-of-plumb membrane fasteners tore through the insulation in a manner suggesting all components were in-place prior to failure, with small particles of EPS insulation balanced delicately on one side of the fastener only. This result would have been difficult to achieve during installation of a rotating screw.

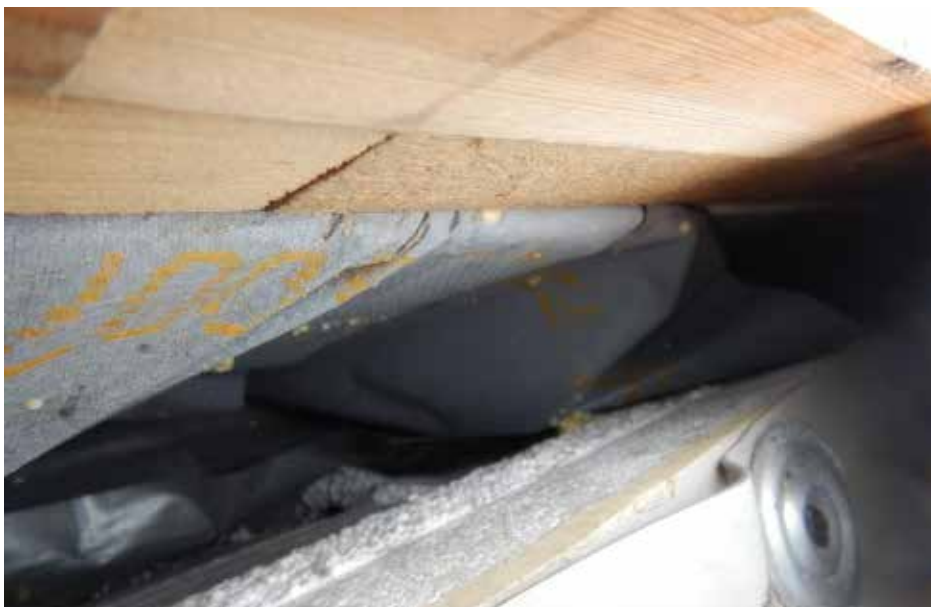
at both openings, roofing screws appeared to have been displaced (Figs. 17 and 18); they were not plumb and had begun to tear through the insulation. In addition, the roof membrane appeared deformed around the head of one of the screws (Fig. 16).

**Figure 16.** *Membrane under tension at washer.*

Figure 16 shows the roof membrane displaced locally around the washer, indicating tension between the membrane and fastener/washer and that anchorage of the membrane at this location had failed. The screw orientation, membrane displacement, and the characteristics of torn insulation indicate that the 2-in. (50-mm) gap observed at both roof openings was not present at the time of installation and that roof assembly had in fact shrunk.

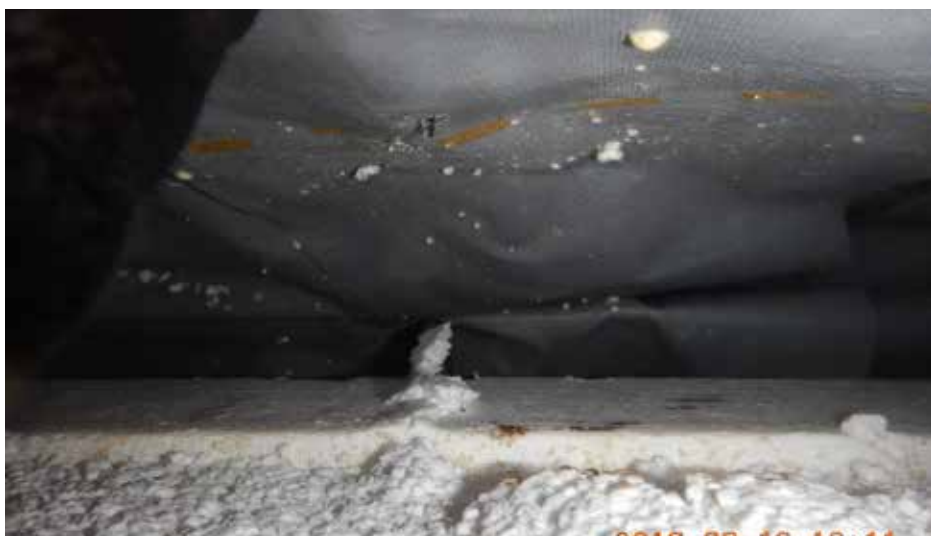
**Figure 17.** *Downward view of rotated membrane screw tears through insulation.*

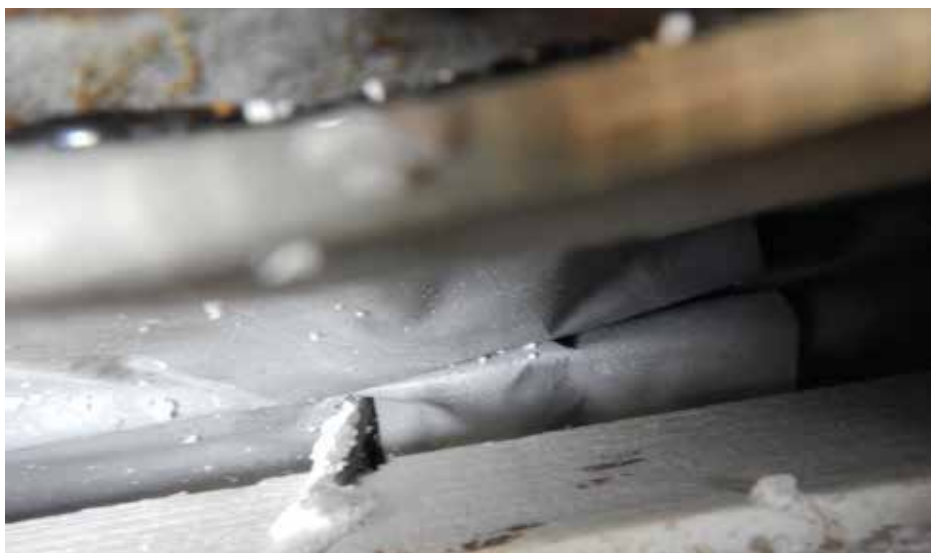
**Figure 18.** *Close up look at the bottom of the insulation, showing more damage on the bottom layer of insulation.*
