# Restoration of Historic Temple Emanu-El

By Tara Ikenouye, AIA, CPHC

*This paper was presented at the 2024 IIBEC International Convention and Trade Show.*

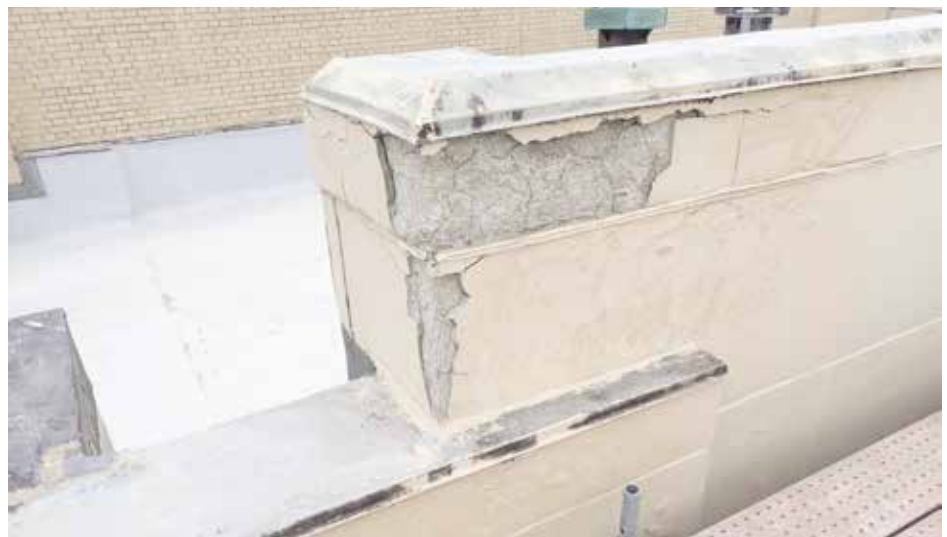
Water had a pathway into to the cast stone facades from troublesome conditions present at the sanctuary. Sealant installed at mortar joints had blocked water from migrating out of the wall through these joints. The layers of coatings that were intended to protect the cast stone from moisture actually trapped water within the concrete when moisture bypassed the coating through splits, voids, and peeling coatings. Through-wall flashings with short drip edges were also sealed without weeps. As composite mass-masonry walls, the facades of the sanctuary

Figure 3. Cast stone units at the parapet with freeze-thaw damage and coating failure.

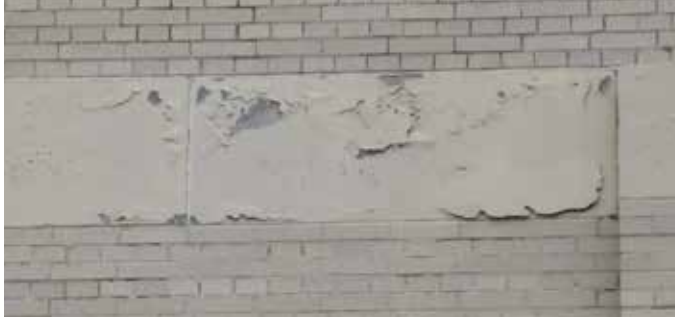
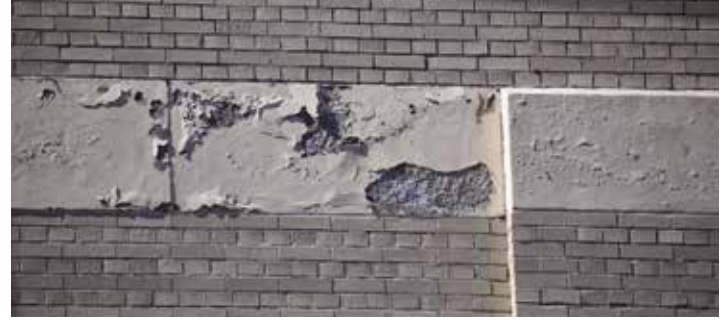
Historical photographs from the time of original construction show that the cast stone elements of the sanctuary were not coated. However, by 2015 when WJE was first engaged by the Temple, coatings that had been applied on the cast stone starting in the early 1990s exhibited pinholes, splits, and blistering, and were delaminating at many locations. Where the coating was distressed or damaged, the underlying cast stone also exhibited craze cracking, uneven surface texture, pockets of efflorescence, and incipient spalls. Multiple cast stone units at sanctuary facades had damage from cycles of freezing and thawing (Fig. 3 and 4). As part of the initial condition assessment, core samples from three cast stone units were removed for petrographic analysis. Samples of the various coatings were also removed to study the many layers and types of coatings applied to the cast stone.

**Figure 4.** Cast stone units at the belt course with blistered and peeling coatings and efflorescence. The top and bottom photos are from 2015 and 2019, respectively.

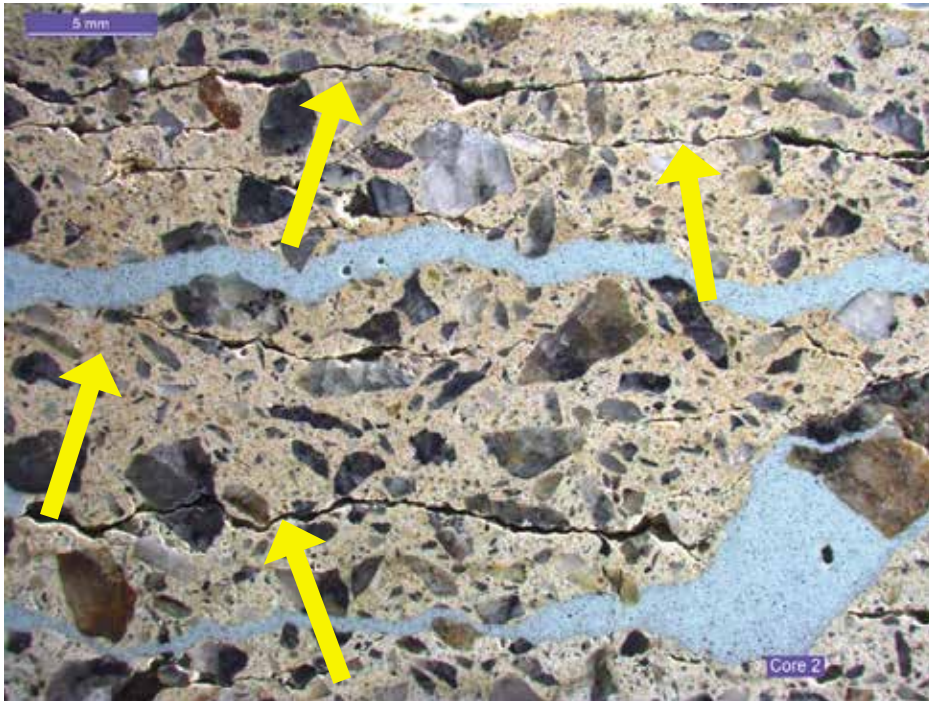
The petrographic analysis was used to microscopically assess failure mechanisms, mixture proportions, and air entrainment in the concrete. It demonstrated that the sampled cast stone was a wet cast mixture versus dry tamp cast mixture, which are the two methods to manufacture cast stone units. The mixture was not air entrained and exhibited properties consistent with a mixture that had a high water-to-cement ratio. The non-air-entrained concrete made the cast stone units more susceptible to freeze thaw damage, which was consistent with findings from the petrographic study. The parallel microcracks present at the outer end (the exterior face of the cast stone unit) and inner end (the face of the unit next to backup masonry) of two sample cores were a result of cyclic freeze-thaw deterioration (Fig. 5). Without air voids to accommodate expansion within the units from the pressure of ice formation during freezing-and-thawing cycles, the concrete cracked. The finding that the inner end of the core samples showed deterioration from freezing and thawing indicated that the unit embedded within the mass-masonry wall was experiencing saturated conditions. This finding aligned with overall conditions of the sanctuary facades.

**Figure 5.** This is a cross-section sample from one of the cast stone core samples. Parallel microcracks in a cast stone sample are indicative of damage from cycles of freeze-thaw damage.

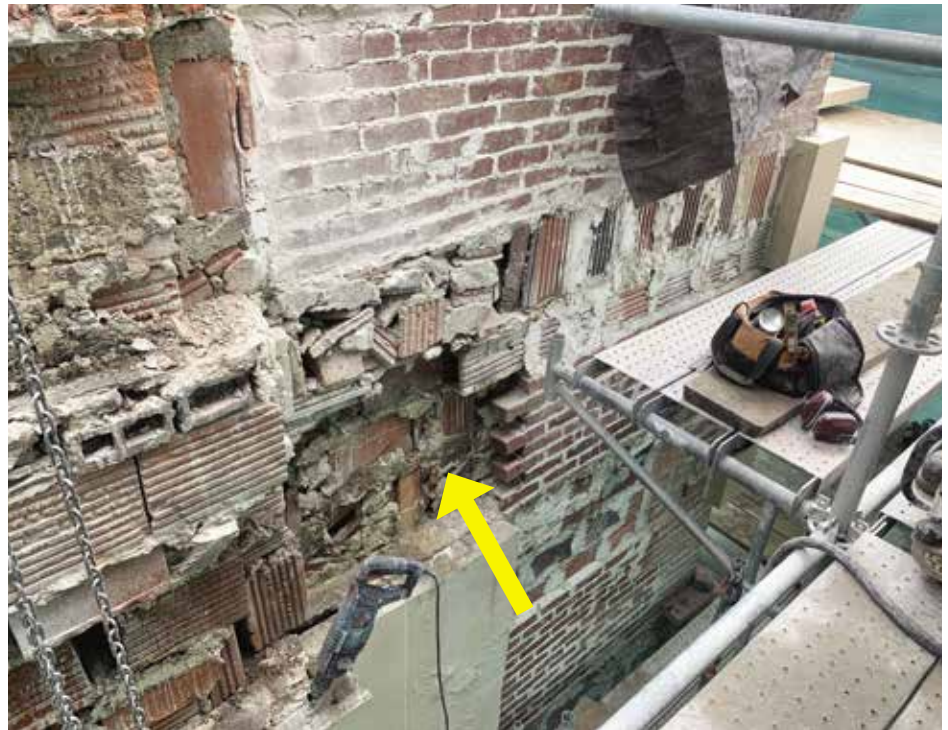
**Figure 6.** The removal of cast stone units from the sanctuary facade exposed structural clay tile back-up masonry. Note the void where 8-in.-deep (203-mm-deep) units were removed (arrow).

The restoration project designed by WJE was based on findings from the investigation in 2015, and additional investigation in 2019. Without historical drawings, information about the as-built construction of the sanctuary had to be collected through fieldwork and inspection openings. From the inspection openings, the project team learned that the cast stone units alternated between 4 and 8 in. (102 and 203 mm) deep. The team decided to design new cast stone units to be 3½ in. (89 mm) deep to allow for a ½ in. (13 mm) joint for new adhesive anchors and grout. The expectation was that the 8-in.-deep units would remain embedded in the backup masonry with the outer 4 in. cleaved off. However, once the masonry contractor started removing cast stone units, they proposed fully removing the 8-in.-deep units and infilling with brick masonry (Fig. 6).

This approach was easier for the masons and maintained the load path of the back-up masonry wall.

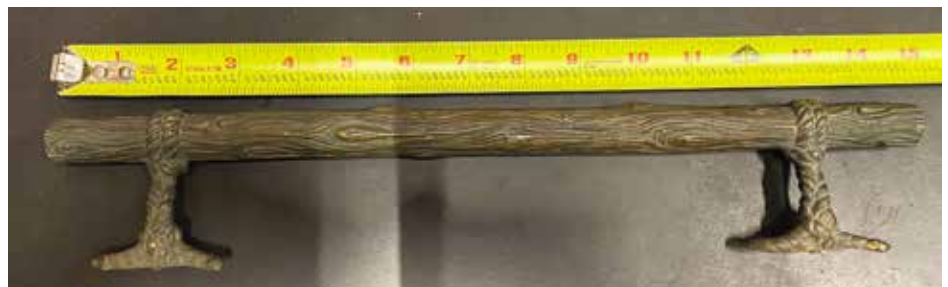
**Figure 7.** Historic door pull handle found in storage room. A mold based on this handle was used to cast new bronze pull handles for the restored front doors.

surfaces were removed and carefully restored off site. During construction, the property manager for the Temple found one of the historic bronze door handles in a storage room. The contractor located a nearby foundry to mold and cast new handles for all three doors (Fig. 7).

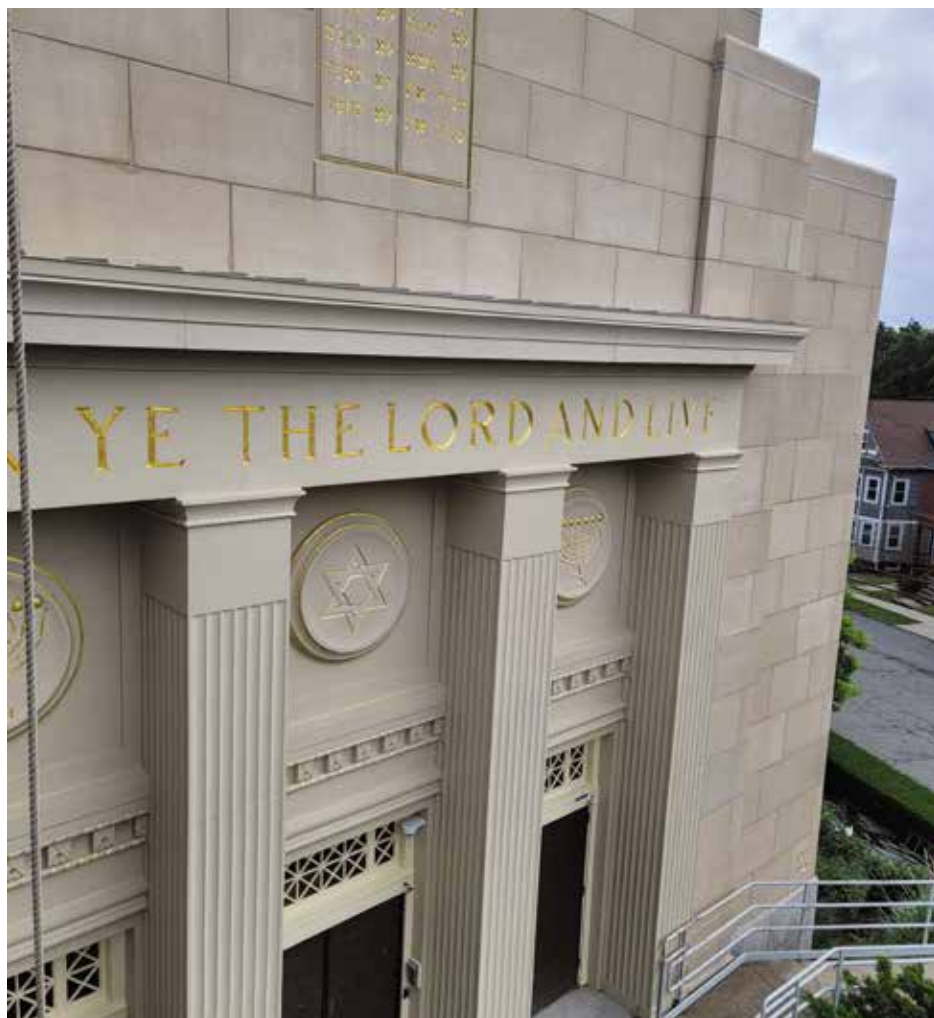
**Figure 8.** The restored Temple Emanu-El with new cast stone units, a glass-fiber-reinforced polymer cornice, and gilding completed.

The cast stone units that comprised the cornice were large and deeply embedded in the exterior wall, and the original plan for restoration and repair at the cornice above the portico was primarily localized concrete repair. However, when demolition was underway, it became apparent that freeze-thaw damage was widespread in the projecting sections of the cornice and would require extensive concrete repair. The Temple, WJE, and Gnazzo agreed that retaining the embedded sections of the cornice, removing the deteriorated concrete, and replacing the cornice with a new glass-fiber-reinforced polymer (GFRP) shell was an appropriate option. Aesthetically, the GFRP was a smart choice because the shell could match the profile of the existing cornice as well as the color of the new cast stone units and new coating. The GFRP shell also replaced concrete, which would have continued to deteriorate and require regular repair.
