# Brick by Brick: Traditional and Unconventional Masonry Restoration Strategies

By Patrick E. Reicher, REWC, REWO, SE;  
Gloria A. Frank, EIT; Anna L. States

This paper was presented at the 2023 IIBEC International Convention and Trade Show.

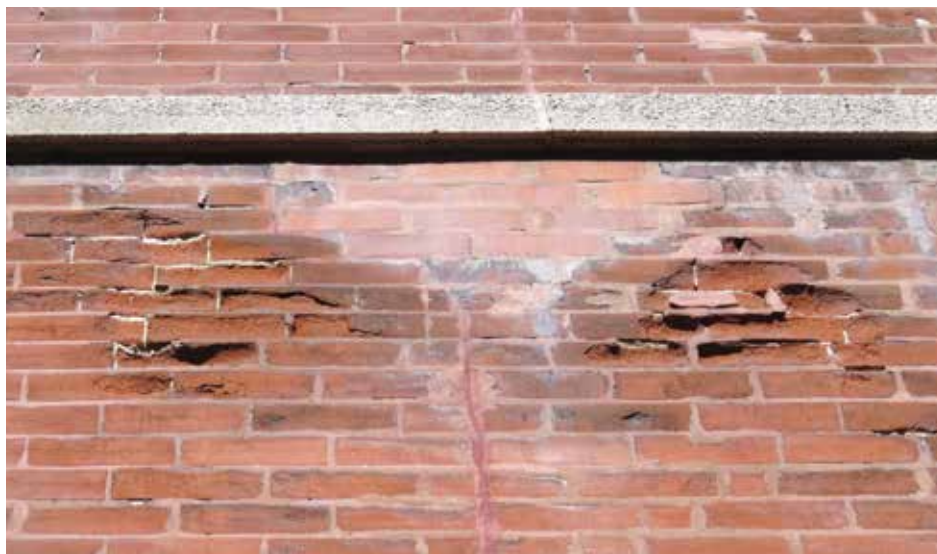
Figure 2. Various forms of exterior masonry wall deterioration.

Like most construction materials, masonry is subject to deterioration over time in the presence of moisture, other environmental factors, and loading (Fig. 2). The following are several types of masonry distress:

- **Cracking:** Cracking is defined as a splitting within masonry units, mortar joints, or both, due to one or many internal or external stresses.
- **Delamination and spalls:** Delamination involves debonding of the exterior surface of a masonry unit and can present a potential

fall hazard. A delamination that has separated from the unit, revealing the inner surface of the masonry unit to the elements, is classified as a spall.

- **Bond line separation:** This type of masonry distress is a failure in the bond between masonry units and mortar joints.
- **Mortar washout:** Mortar washout is defined as mortar deterioration and erosion of the mortar from within the joint.

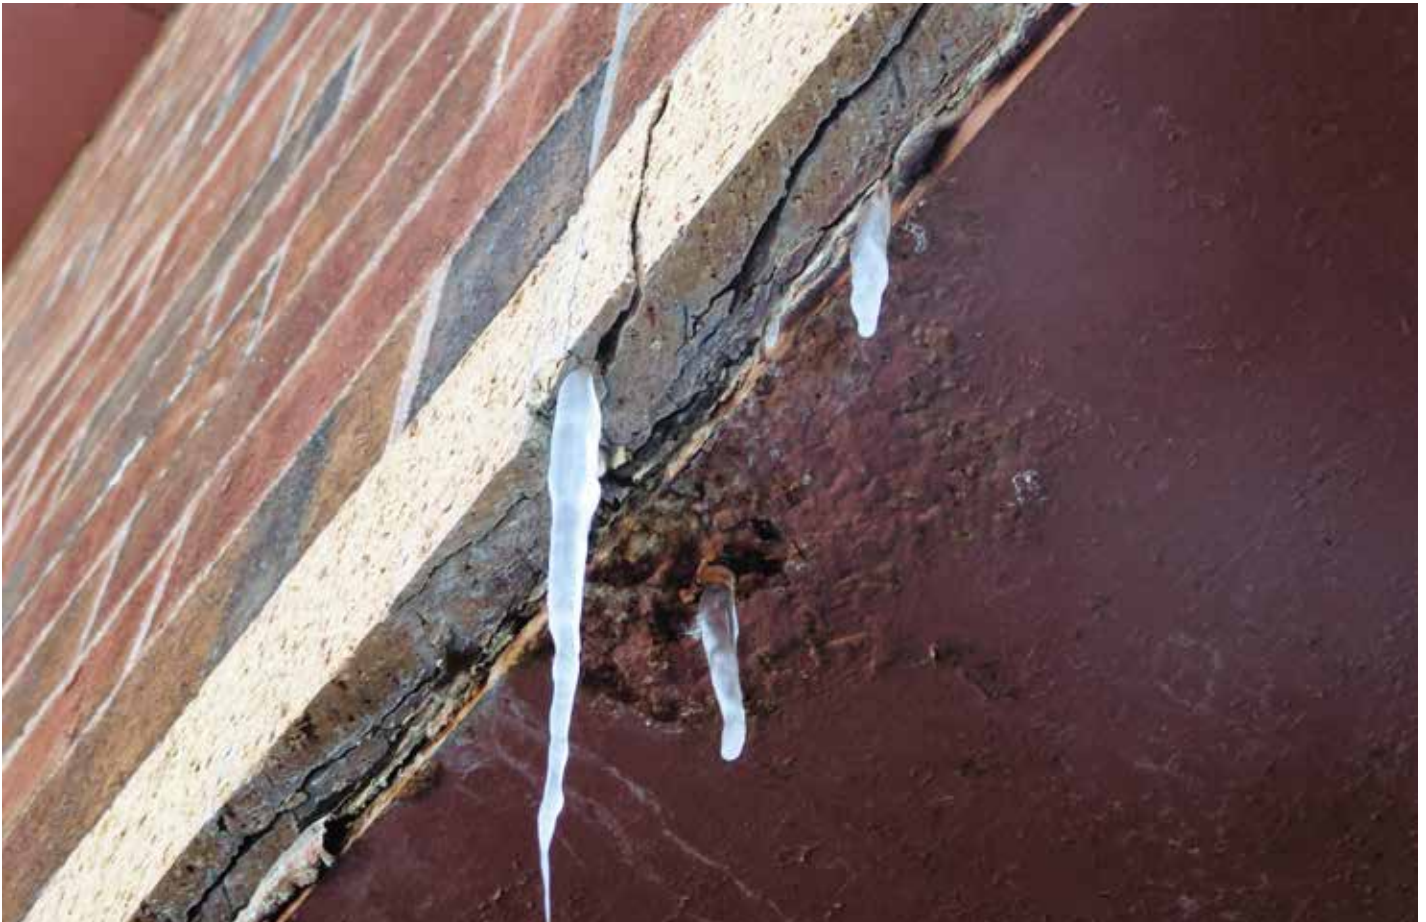
**Figure 3.** *Deterioration of brick veneer from freezing and thawing cycles.*

- **Deterioration from freezing and thawing cycles:** When water freezes and expands within the pores of a masonry unit, internal tensile stresses within the material can lead to cracking, delamination, and possibly spalled units (Fig. 3).
- **Efflorescence:** Efflorescence is generally a benign form of distress in which light-colored minerals are deposited on the surface of masonry units after water evaporates from within the walls. Efflorescence can occur on both the interior and exterior sides of the walls.
- **Corrosion of metal components:** Water provides an ideal environment for steel corrosion if chlorides or other corrosion-promoting chemicals are present.

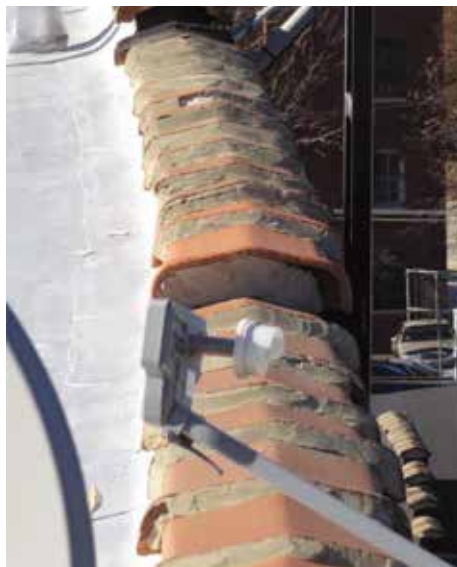
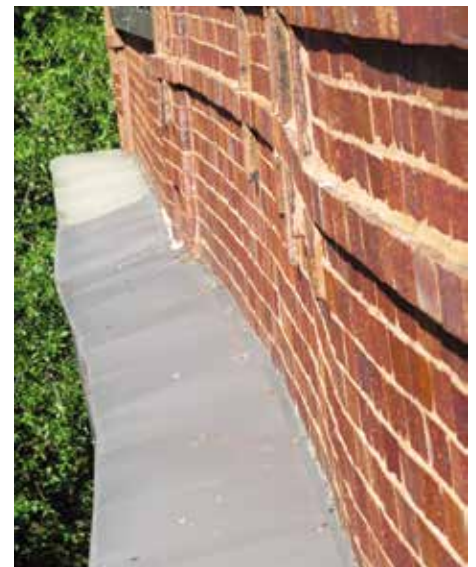
**Figure 4.** *Two examples of masonry wall bowing due to lack of movement joints.*

Displacement, bowing, and bulging can also occur due to compression stresses, inadequate lateral support, lack of adequate movement joints, or a variety of other reasons (**Fig. 4**). Dimensional changes can also occur due to creep of CMUs or a backup concrete structure, volume changes (masonry walls are constantly expanding or contracting), and other factors. Displacement and dimensional changes can cause masonry to deteriorate, especially in areas of restraint where the natural movement of exterior wall components is restricted.

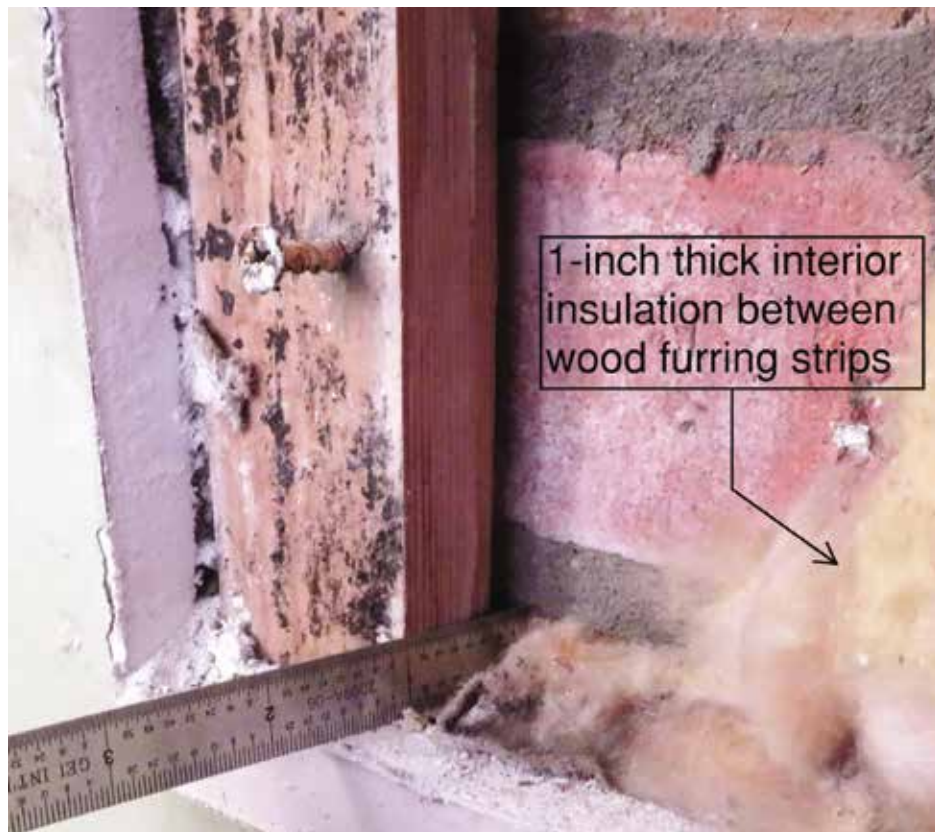
**Figure 5.** A thin layer of insulation provided on the interior side of a mass masonry wall.

The large thermal mass of mass masonry structures assists in reducing temperature fluctuations within buildings. As such, insulation was typically not provided within or inboard of the walls. In some cases, a thin layer of insulation was provided on the interior side of mass masonry walls (**Fig. 5**).

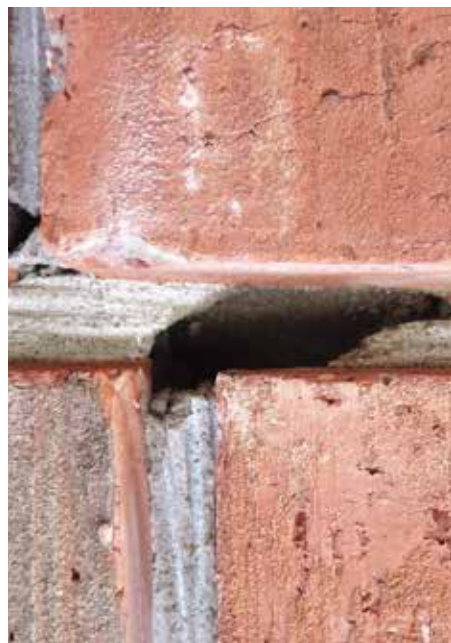
**Figure 6.** Voids in a mortar joint were uncovered following grinding during a repointing project.

However, without proper design and industry-standard construction methods, conventional masonry restoration strategies can have limited benefits or result in aesthetic concerns. As an example, repointing is a common repair practice that requires removing deteriorated mortar to a uniform depth and placing new mortar within the joint. The deteriorated mortar should be removed to a uniform depth that is a minimum of twice the joint width, generally  $\frac{3}{4}$  in. (19 mm), or until sound mortar is reached. If mortar is not removed to an adequate depth, deficiencies in the joint within the depth of the wall may not be uncovered (**Fig. 6**). Repointing performed to a limited depth is likely to provide only minimal benefits when compared with grinding and repointing to at least a  $\frac{3}{4}$  inch depth (**Fig. 7**).

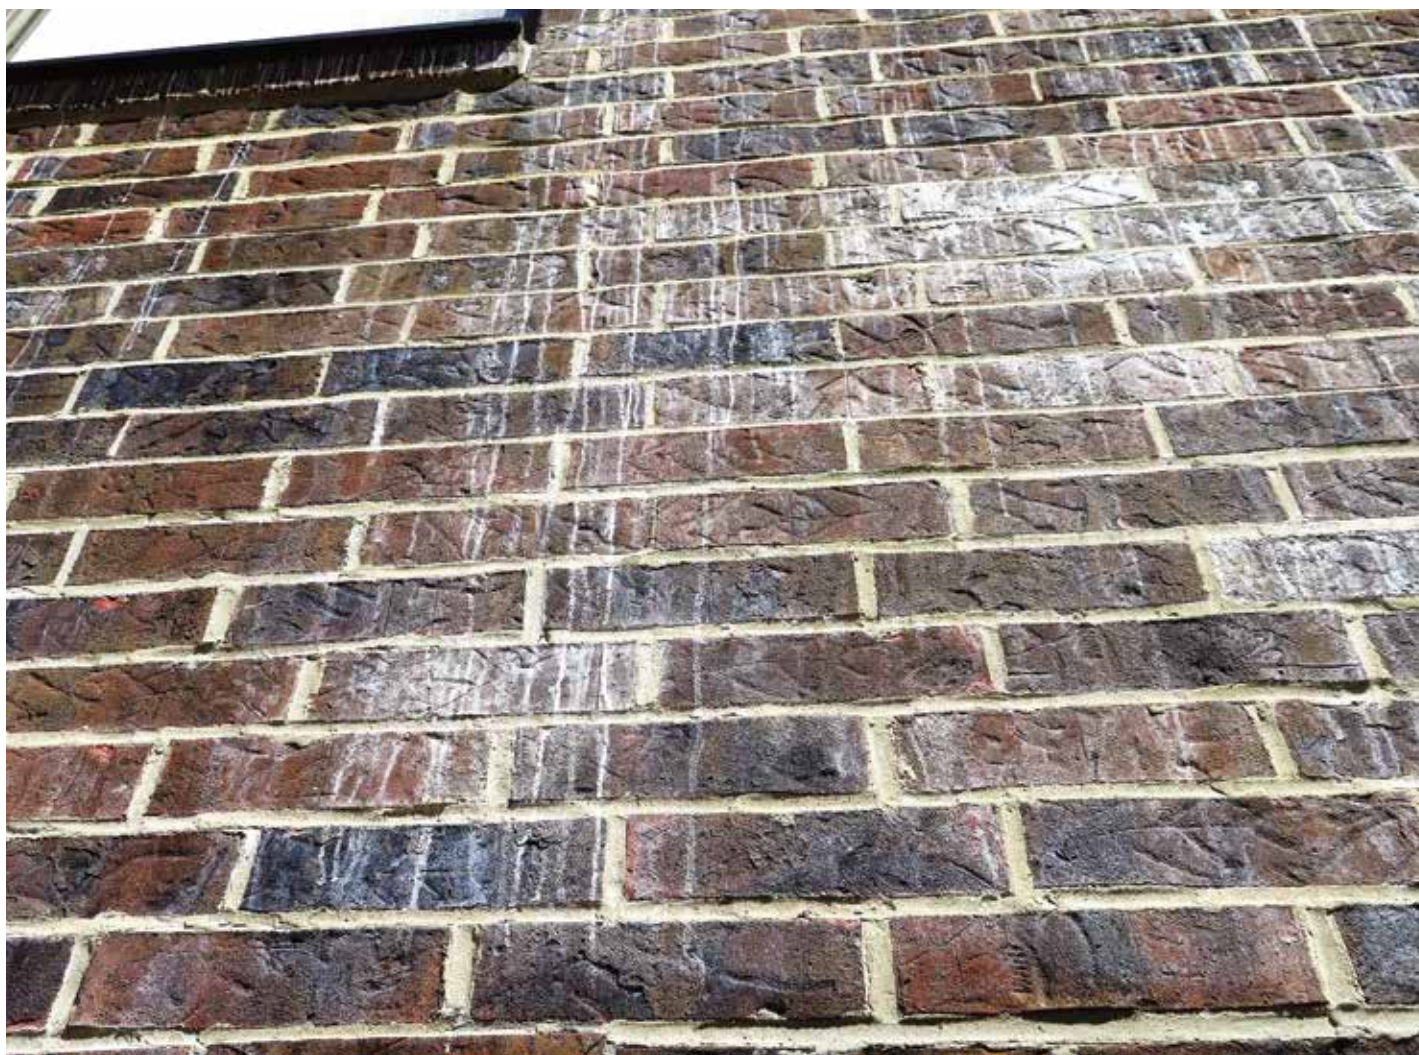
**Figure 8.** *Water-repellent staining on an exterior masonry wall surface.*

details that resist water penetration such as through-wall flashing and weeps in masonry cavity wall construction. Additionally, only products that permit evaporation and the passage of water vapor, such as siloxanes and silanes, should typically be applied to exterior masonry walls. Although water repellents are widely used as part of exterior masonry wall restoration projects, they typically do not provide protection at crack locations in masonry units and mortar joints. Additionally, water repellents must be reapplied at regular intervals of approximately 5 to 10 years to remain effective. In cases where water repellents are incorrectly applied, staining can occur (**Fig. 8**).

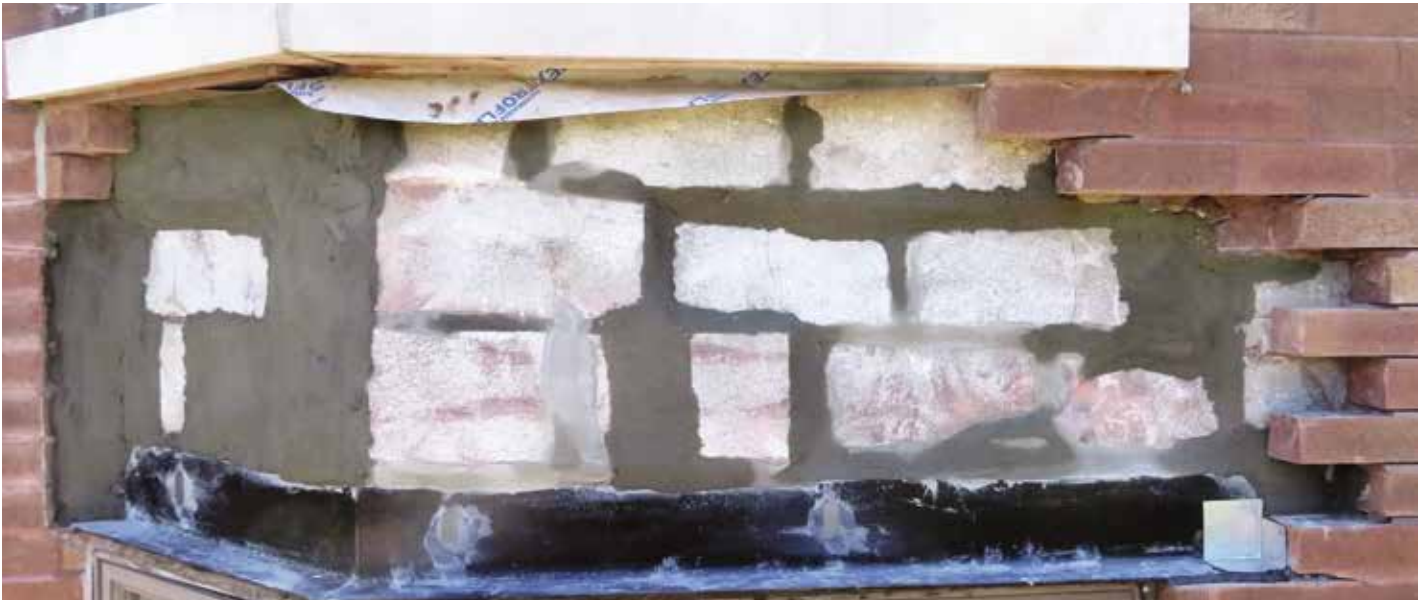
**Figure 9.** Preparation of a backup wall prior to installation of the AWB and through-wall flashing.

Project specifications required repairs to the backup wall in the form of repointing, parging, and unit replacement to ensure a suitable substrate for the AWB and through-wall flashing (Fig. 9). Although traditional through-wall flashing repairs are typically limited to the

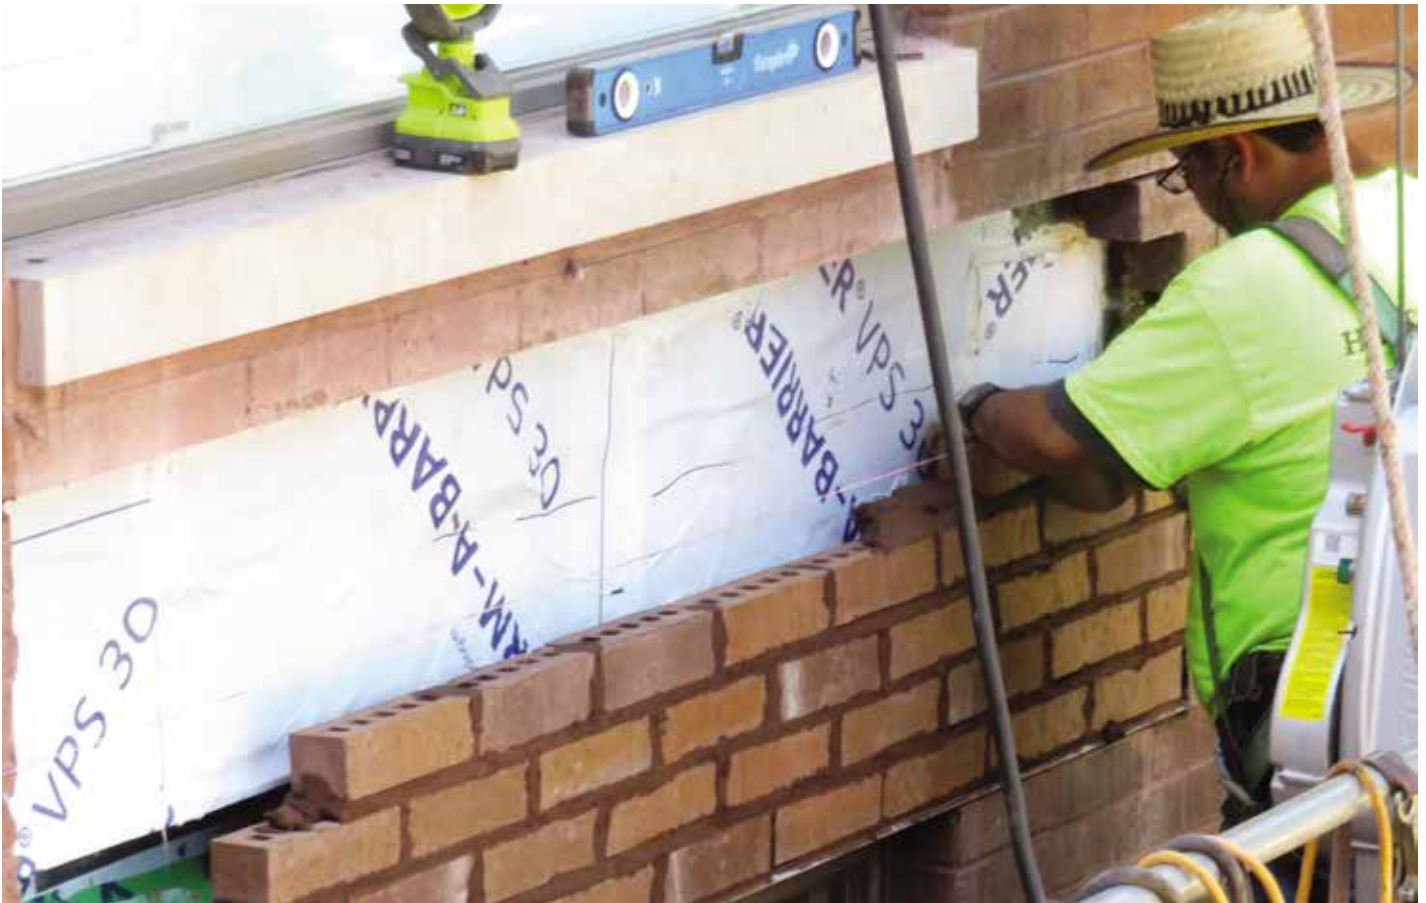
**Figure 10.** Installation of brick veneer following installation of the AWB and through-wall flashing.

three or four courses above steel lintels, the additional repairs performed for this project were intended to limit the possibility of water leakage through deficient areas of the backup wall structure above the areas of through-wall flashing repairs (Fig. 10).

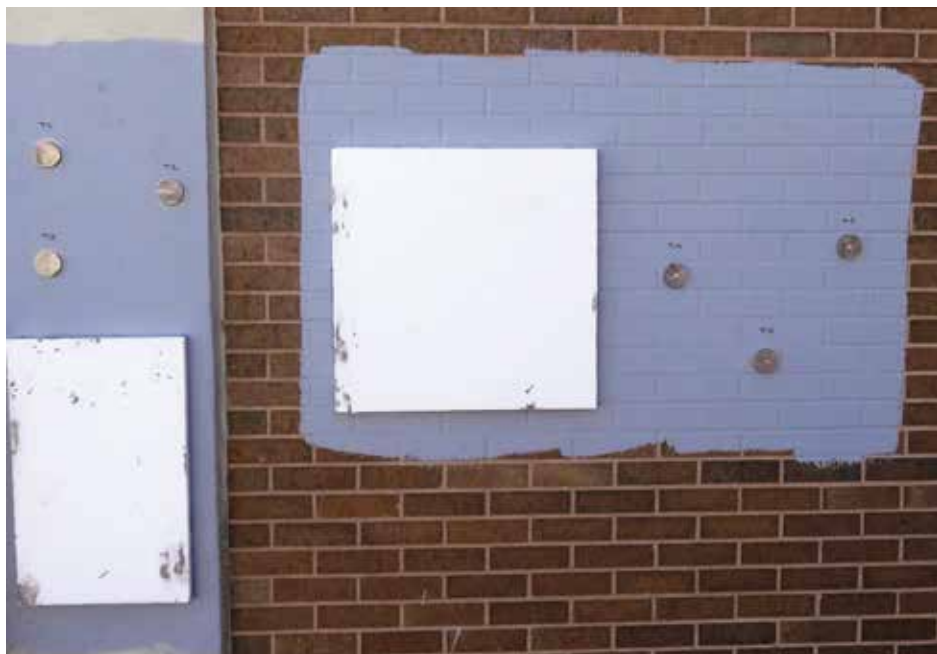
**Figure 11.** Mock-ups installed to evaluate adhesion of the AWB to substrates and the EIFS insulation to the AWB.

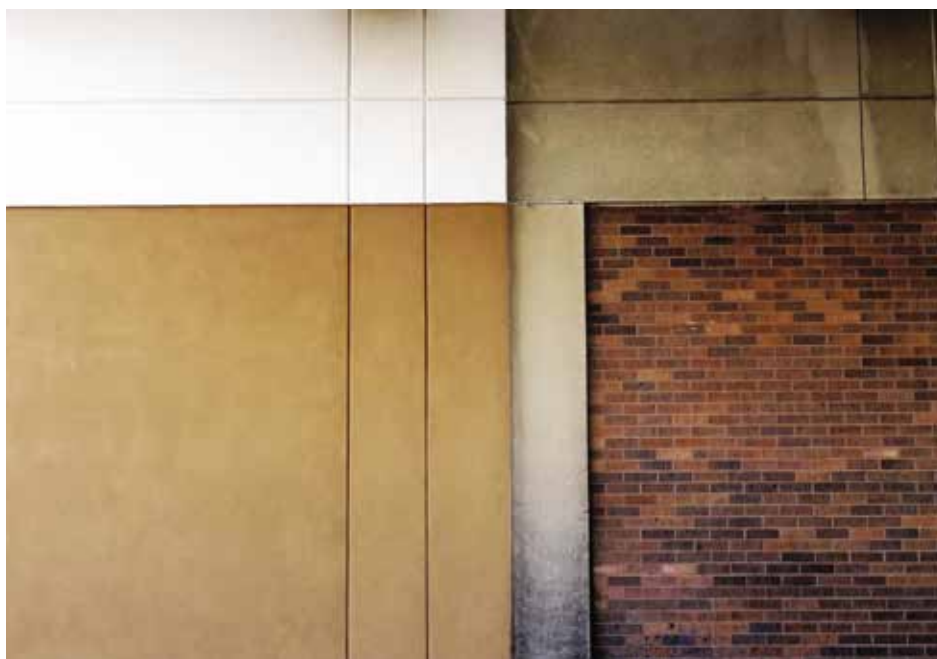
**Figure 12.** Completed overclad area of the EIFS adjacent to the existing masonry exterior wall.

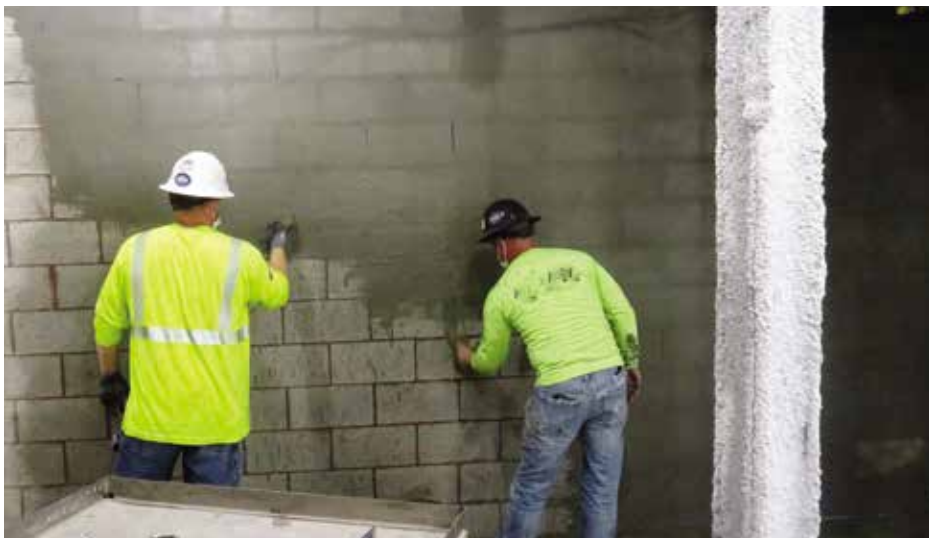
**Figure 14.** Crystalline waterproofing application on the interior side of a CMU wall.

Following demolition of interior finishes, water leakage through the field of the walls and at through-wall flashing locations was documented on several occasions during precipitation events. Therefore, the authors recommended a hybrid repair strategy that would incorporate traditional masonry repairs and window replacement in conjunction with application of a crystalline waterproofing system on the interior face of the CMU walls (Fig. 14). In general, the crystalline waterproofing application required the following:

- Cleaning the interior faces of CMUs and mortar joints so the surfaces would be free of foreign materials.
- Repointing cracked and deteriorated mortar joints on the interior face of the wall.
- Wetting the wall to a saturated surface damp condition and rewetting continuously until water was no longer accepted.

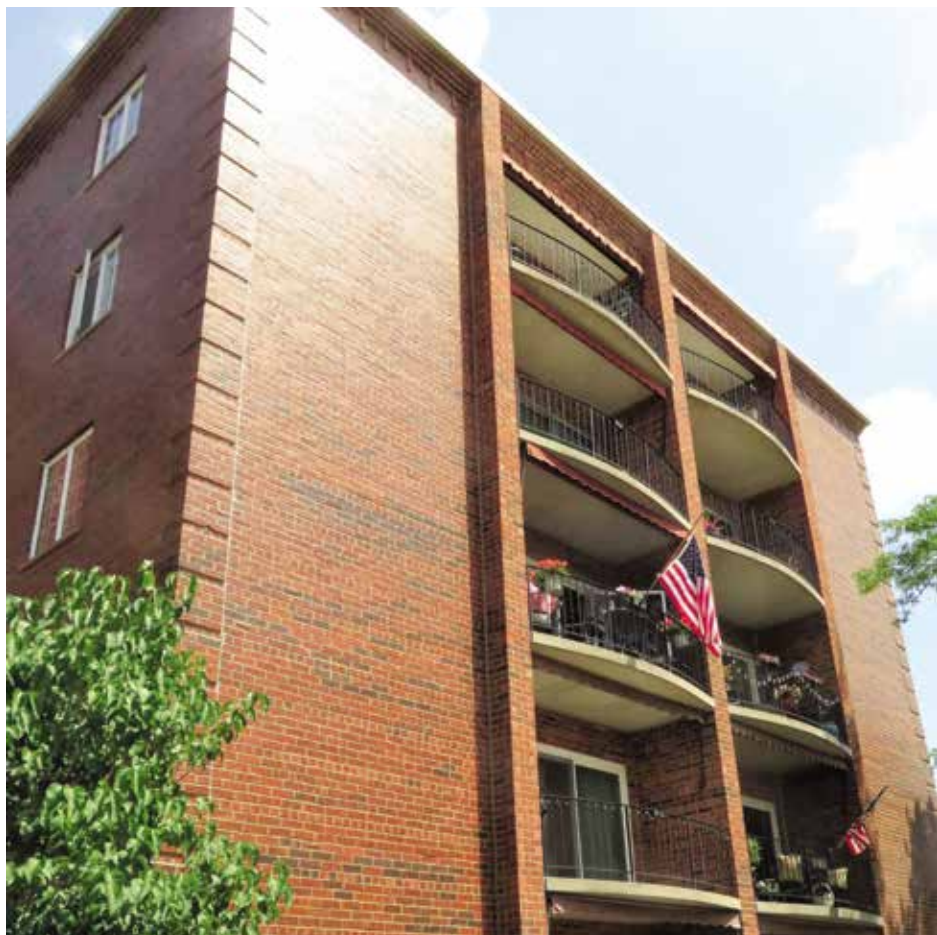
**Figure 15.** Translucent silicone coating applied to the exterior face of a two-wythe mass masonry wall.

The authors determined that traditional repairs alone would unlikely resolve the water leakage issues at the building because the exterior wall system lacked sufficient mass. The recommended repair project involved localized brick replacement, 100% repointing, and sealant replacement. In addition, a translucent vapor-permeable coating was applied to the restored exterior wall surfaces. The translucent coating was applied in two thin layers to ensure that the coating would remain vapor permeable after repairs were completed, thus allowing for evaporation of water that may penetrate through coating imperfections over time. This strategy essentially changed the wall behavior from that of a mass masonry wall to a barrier wall system, thus improving the performance of the exterior wall with respect to water penetration. Although the translucent silicone coating has resulted in a slight sheen that was not present in original conditions, the exterior masonry remains visible through the coating (**Fig. 15**).

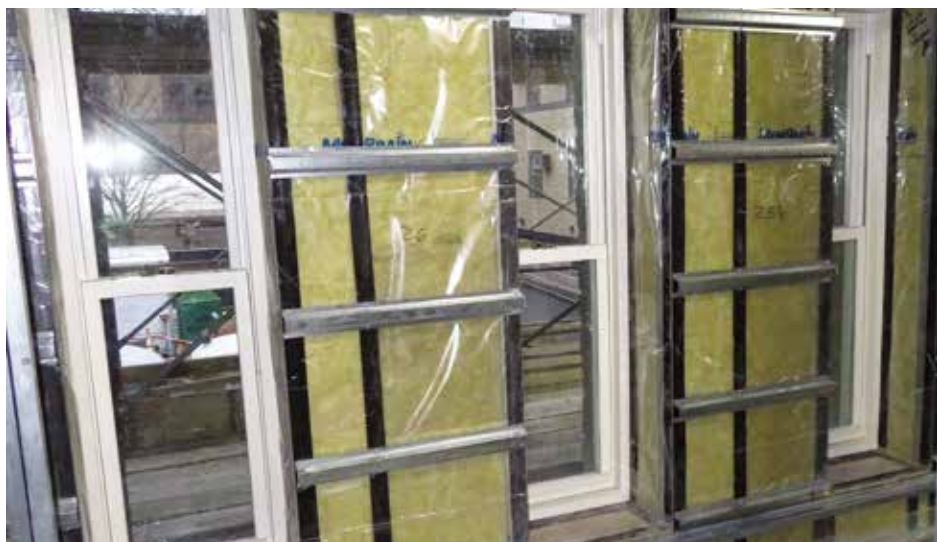
**Figure 16.** Interior insulation and a variable vapor retarder installed on the interior side of a mass masonry wall.

Exterior insulation was not permitted on this historic structure, so a repair approach was developed that provided an air gap on
