# A Not-So-Perfect Storm: The Convergence of Large Buildings, Wood Decks, and Mechanically Attached Low-Slope, Single-Ply Roofing Systems

By Richard Gustin; Rob Hughes, CDT

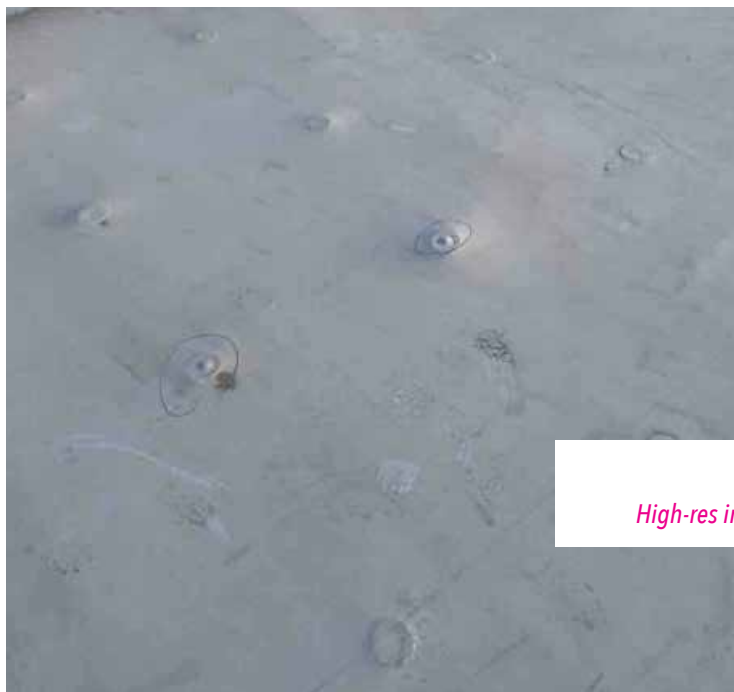
One specific project stood out and was the impetus to begin additional research on how fasteners are driven in the field. A three-building complex in the Southwest with induction-welded TPO exhibited varying levels of damage on each building, from nearly none to extensive loss of cover board and membrane (**Fig. 1**). The damage was not consistent with wind direction or any

**FIGURE 1.** Extensive fastener withdrawal with no corresponding wind event.

building features, and no evidence of a wind event was present on the surrounding grounds. The fastening pattern was relatively robust, with perimeter and corner enhancement present. The areas of damage were random, with the field, perimeter, and corners all affected. While maximum wind speeds were recorded as only 45 mph, certain sections lost all their fasteners, and no spalling damage was evident in the OSB decking. The fasteners pulled out cleanly.

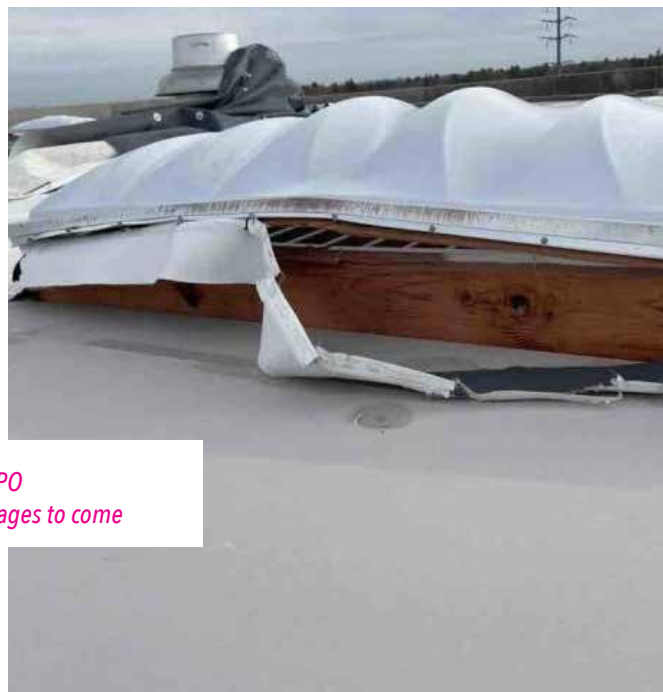
**FIGURE 2.** Curb and skylight separation from the deck.

A 3,900-square facility in North Central California was documented with skylights, HVAC, and various smaller curbs separated from the deck (Figs. 2 and 3). The membrane did not appear to cause this damage. Holes were observed in the OSB decking at numerous locations as if internal pressure had pushed through it. Backed-out fasteners were observed not at the perimeter or corners where pressures are highest but rather in the field of the roof.

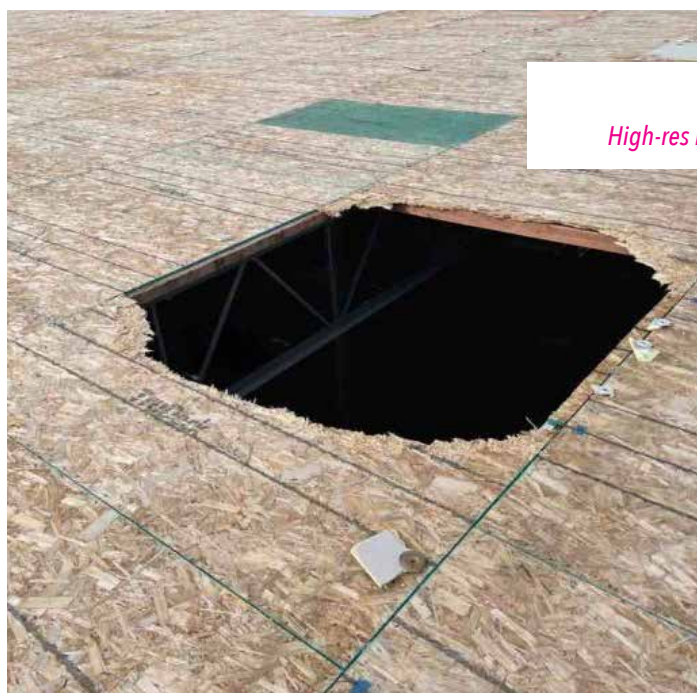
FIGURE 3. Loss of rooftop curb due to possible internal pressurization.

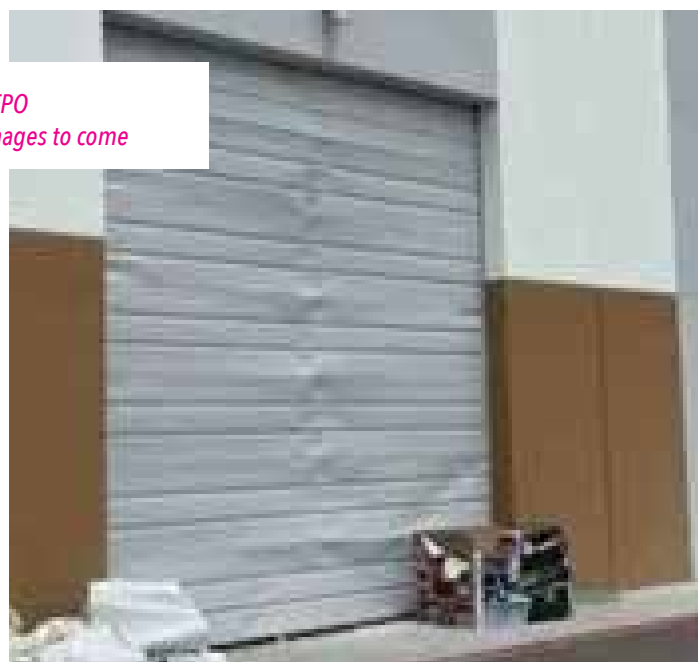
Another 1,670-square facility in the Southwest had wind damage to the interior, including a garage door that was distorted and bent towards the interior of the building (Fig. 4). Winds were

recorded at 64 mph. No obvious causes were evident at the building or roof level, and the door was rated to withstand wind speeds over 100 mph.

FIGURE 4. Garage door damage showing distortion from winds at or below 64 mph.

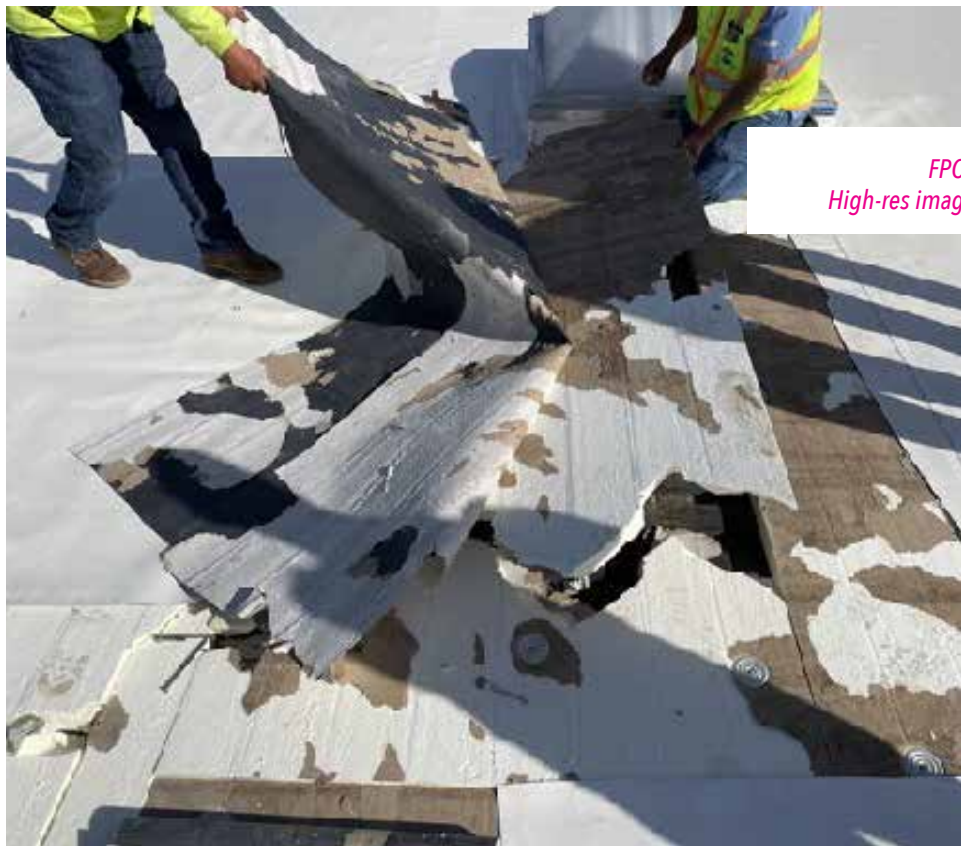
While not a mechanically fastened system over OSB wood decking, a 1,000-square facility in South Central California with an adhered PVC roof over a steel deck experienced approximately 30 squares of damage in the field of the roof (Fig. 5). The membrane was bonded to ISO insulation, which fractured, leaving the fasteners intact; the membrane was still adhered to the boards. These observations are not consistent with a typical wind-related failure, which would generally initiate at the building perimeter or edge. In addition, the membrane would typically peel the facer off the board, leaving the boards otherwise intact. Investigation revealed that the facility had recently eliminated one passive gravity vent in the failure area. Additionally, the facility representative admitted that one bay door was often left open. These scenarios illustrate that real-world, daily building operations should be a material consideration when designing a roof system and the potential power of internal pressure in large warehouse structures.

**FIGURE 5.** Fractured ISO with fasteners and membrane intact.

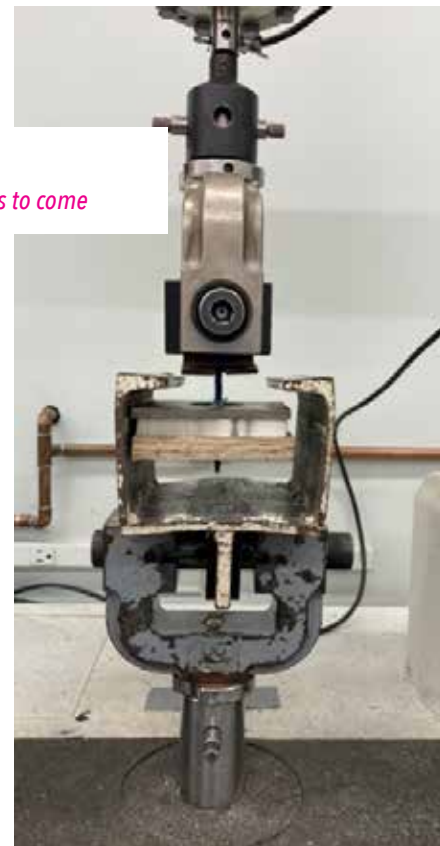
**FIGURE 6.** Instron tensile testing machine.

Fastener withdrawal was conducted on 4 x 4 in. samples to determine pullout values sorted by decking material, weathering of decking, fastener type, and properly torqued vs. over-torqued fasteners (**Fig. 6**)
