# Validating Thermal Performance of Existing Assemblies Using In-Situ Measurements

By Shibei Huang, NFRC Certified Simulator

This paper was presented at the 2024 IIBEC/OBEC BES.

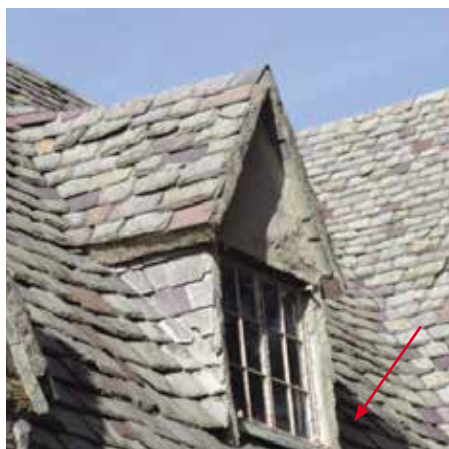
**Figure 3.** Install sensors on the north slope under shade (wintertime); red arrow indicates the sensor location.

**Step 2:** Select measurement locations. Avoid direct solar radiation by deploying sensors in the north (Fig. 2) or use shades (Fig. 3). The next section will discuss the use of a thermal camera in more detail to aid in selecting specific locations.

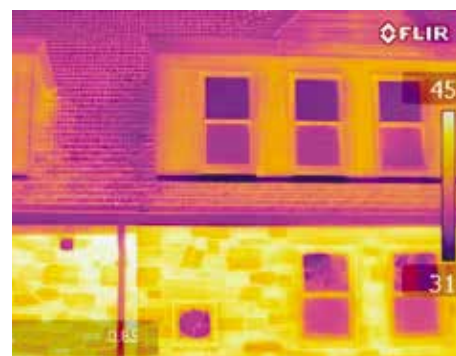
Figure 7. Exterior infrared image of a dormitory building at a college in Philadelphia, Pennsylvania, originally built 1981.

Thermal imaging can help identify conductive components of an opaque enclosure. For example, Fig. 7 is an infrared image of the exterior of a Philadelphia college dormitory, built in 1981, with a slate roof, a stucco wall at dormers, a stone wall, and wood-framed windows. The image was taken in the winter, and analysis of the thermal patterns should exclude the reflection of the cold surroundings and the sky at the insulated glass units (IGUs)

and metal downspouts (note the examples crossed out with white lines). Looking at the thermal image, it is apparent that the stone wall is conducting interior heat to the exterior more than the roof and the dormers. Therefore, the most conductive component of this building enclosure is the stone wall.

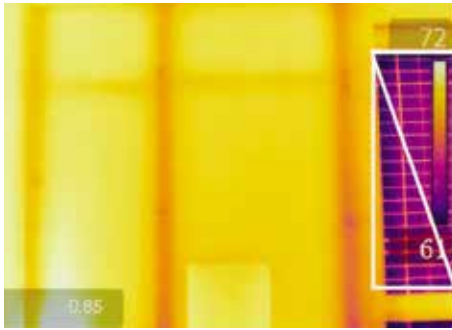
**Figure 8.** Interior infrared image of a wall of a college performance center and office in Philadelphia, Pennsylvania, originally built 1989.

Thermal imaging can also help identify the presence of insulation within a stud cavity. For example, Fig. 8 shows an infrared image of an exterior wall taken in late winter from the interior of an office. The drawings on record indicated that the building, built in 1989, had metal studs at the interior. When analyzing the thermal image, the transmission of the cold surroundings

or the sky should be excluded at the IGU (examples are crossed out with white lines). In this thermal image, profiles of the metal studs are apparent. Note that the field temperature between the metal studs is very close to the interior temperature captured at the interior wall surface to the left (72°F [22.2°C]). From this observation, it can be deduced that the heat loss to the exterior is very slow, and, therefore, the cavity between the metal stud walls is insulated.

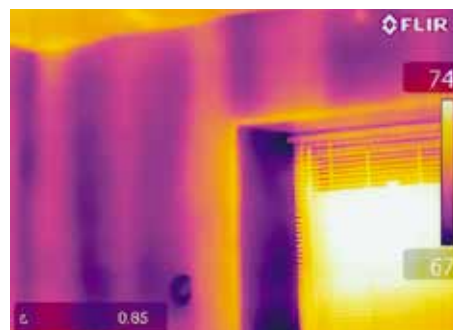
**Figure 10.** Interior infrared image of a historic home and office at a college in Philadelphia, Pennsylvania, originally built 1724.

An infrared camera was used to identify the presence of insulation within the cavity (Fig. 10). Because the surface temperature between the metal studs is lower than the

interior temperature captured at the ceiling (72°F [22.2°C]), it was assumed that the heat loss at the cavity was faster than the wood furring, and therefore the cavity between the metal stud walls was uninsulated.
